### 3. Interior - Common Items Observations and Conditions

**4. Interior - Kitchen Observations and Conditions**

**5. Interior - Bathroom Observations & Conditions**

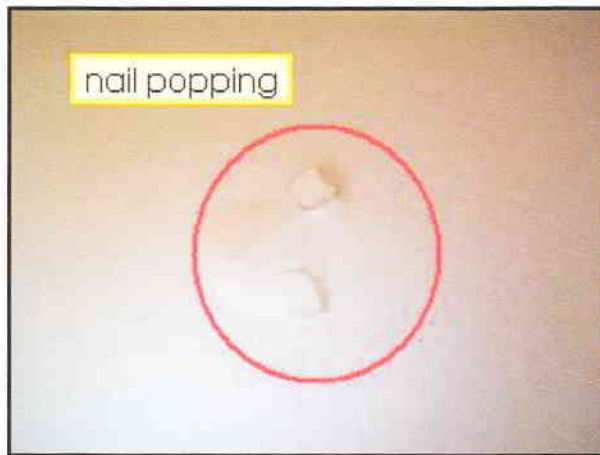
3.1 Picture 1

**CA** - The walls in the attic stairway entrance shows signs of "nail popping and chipping of the drywall. We recommend that all damaged and/or deteriorated walls be repaired to original and proper condition by a qualified contractor with remedy as necessary.

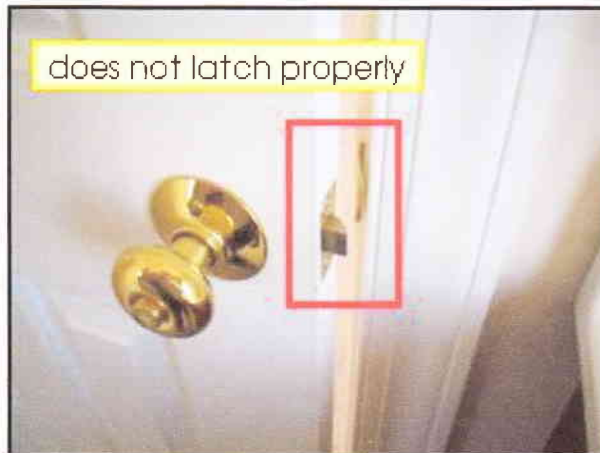
3.3 Picture 1

**NM** - One or more doors located in the jack and jill bathroom did not lock and/or latch properly. We recommend repair with remedy as necessary.

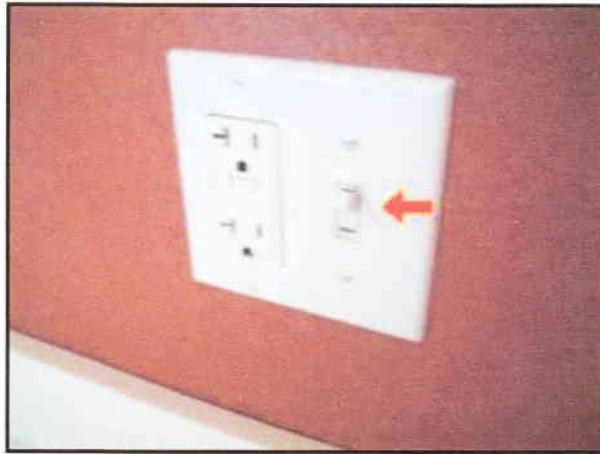
3.5 Picture 1

**CA** - One or more light switches located in the master bathroom did not function properly. This condition can pose a personal safety

*hazard. We recommend repair/replace with remedy as necessary by a qualified electrician.*

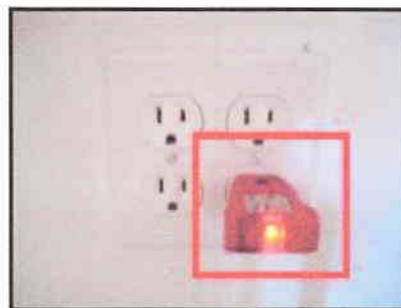
3.6 Picture 1

**CA** - *One or more electrical outlets/receptacles located in the living room, on the right side of the fireplace were observed to be wired incorrectly, and tested as having an open ground or reverse polarity. This condition can pose a risk to personal safety. We recommend that all improperly wired receptacles be repair with remedy as necessary by a qualified electrician.*

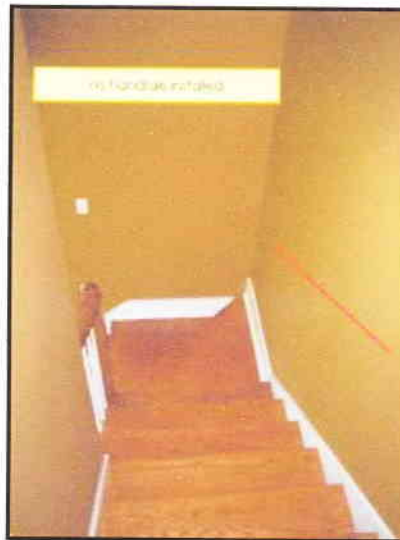
3.7 Picture 1

**CA** - Railings for the stairs leading into the attic do not exist and does not conform to current standards. Although railings may not have been industry standards at the time of construction, or lack of municipal building code enforcement, we recommend installation of railings to conform to current standards for safety with remedy as necessary by a qualified contractor.

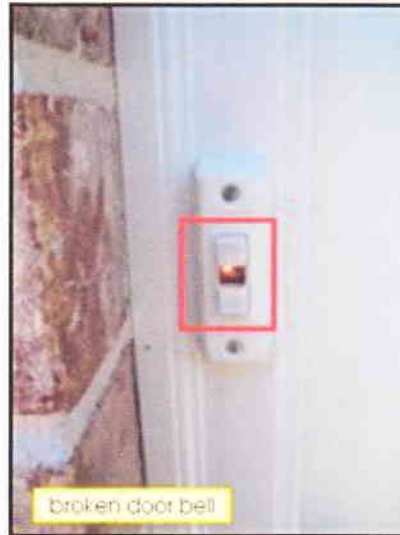
3.9 Picture 1

**NM** - The front door bell was tested and functioned as intended but the button for the door bell is damaged. We recommend repair or replace with remedy as necessary.

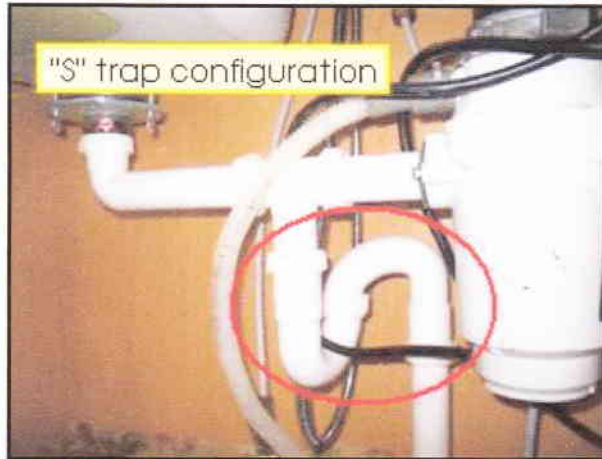
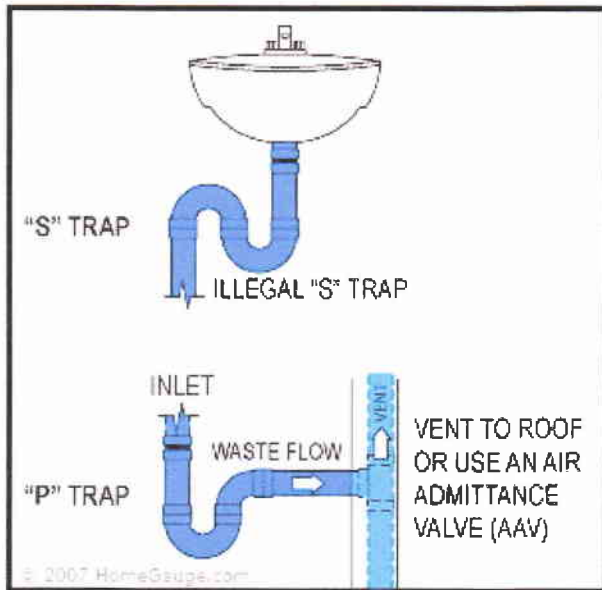
**CA** - The sink drain and/or drain trap located in the kitchen has an "S" type plumbing trap configuration. "S" type plumbing traps are prone to losing their trap seals due to the potential for the "S" configuration to siphon the water from the trap. We recommend repair with remedy as necessary by a qualified plumber.

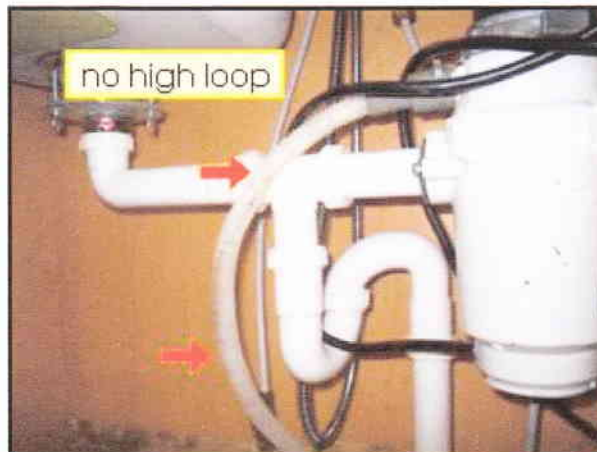
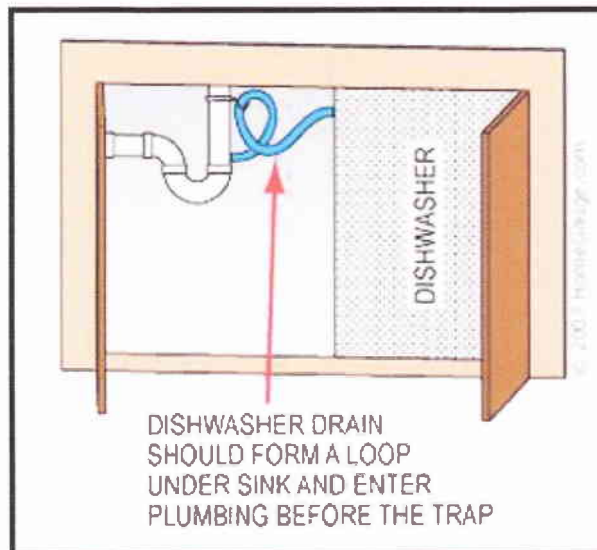
**CA** - The dishwasher drain has a high loop installed in the drain line under the sink but the drain line is installed to low and may allow water to drain back into the dishwasher from the sink. The dishwasher drain line should be secured as high as the sink base to ensure water does not drain back into the dishwasher. The dishwasher will function as is, however, we recommend securing the drain line at a higher location under the sink with remedy as necessary.

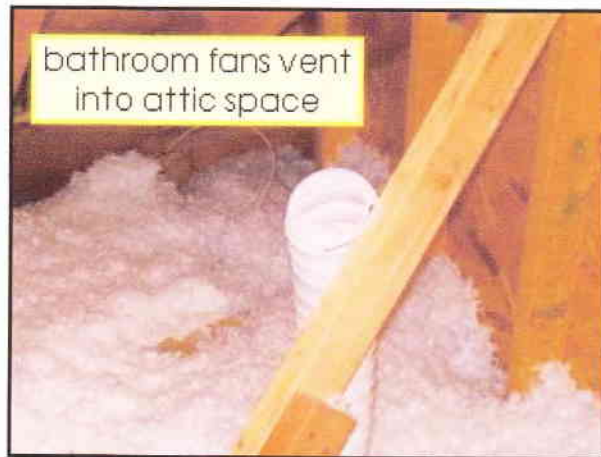
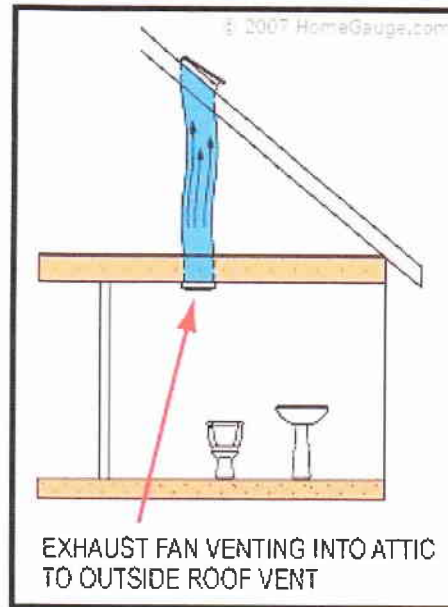
**CA** - Due to lack of municipal building code enforcement, the ventilation/exhaust system for the building bathrooms vents into attic space and should vent to the outside. Although this configuration of ventilation (into the attic) is an old practice and not consistent with current industry standards, it is common practice in this part of the country and is still used in current day new construction. We recommend consulting with a qualified contractor to determine what corrective action is necessary and repair with remedy as necessary.
