12. CRAWL SPACE OBSERVATIONS AND CONDITIONS

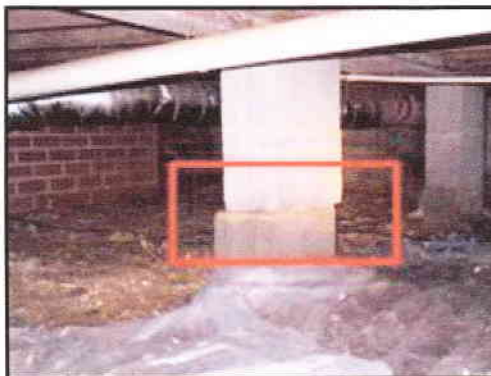
12.2 Picture 1

CA - One or more of the concrete masonry blocks have shifted and lack proper support within that area. We recommend repair with remedy as necessary by a qualified structural contractor.

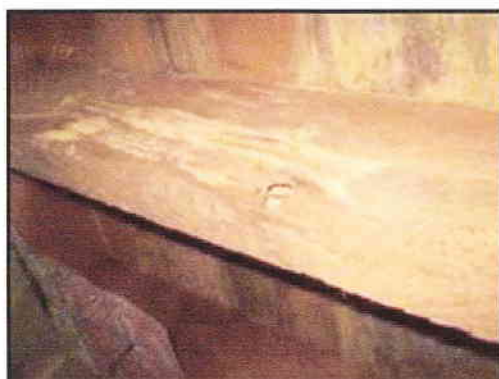
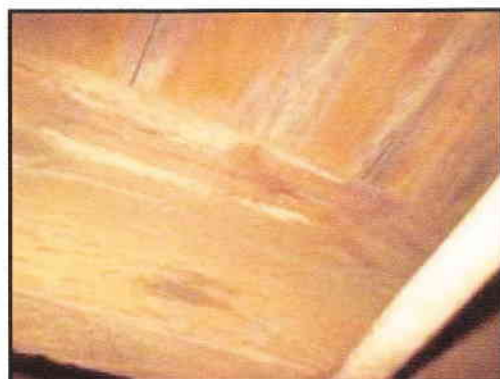
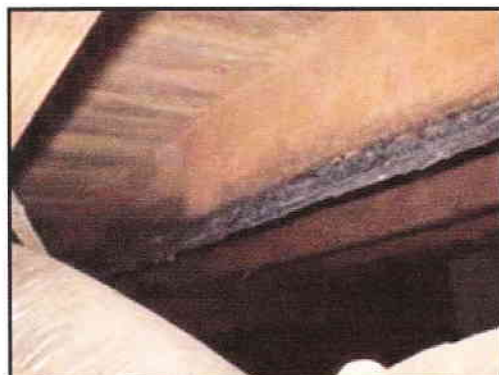
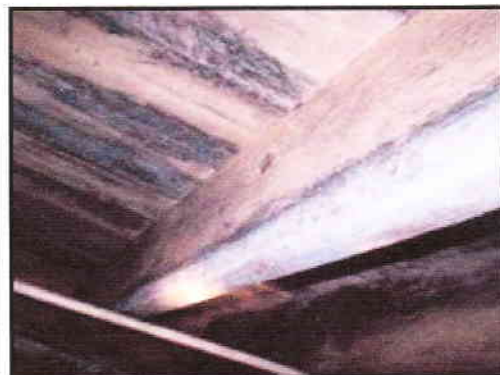
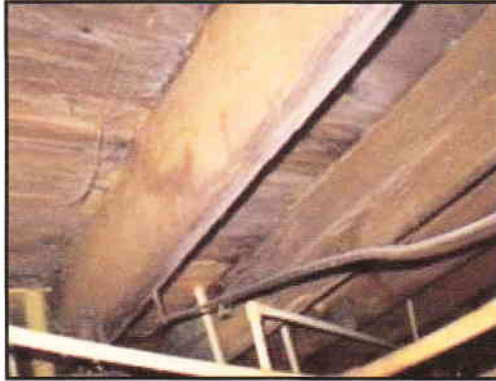
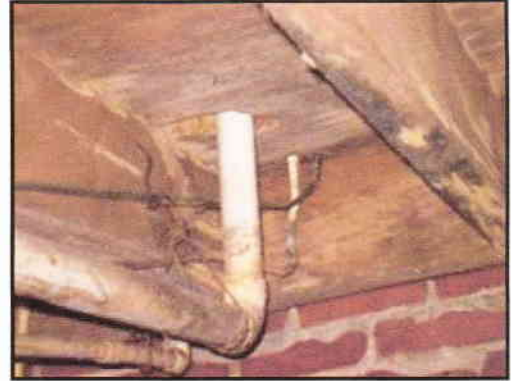
CA - One or more of the framing floor members under several areas were damaged and/or deteriorated that is consistent with and characteristic of wood destroying insects. We recommend treatment by a qualified pest control contractor and repair with remedy as necessary by a qualified structural contractor.

CA - One or more of the framing floor members has a condition that is consistent with and characteristic of mold and was observed throughout the flooring area within the crawlspace. Mold can break down the cell structure of the wood causing to a condition that consistent with and characteristic of dry rot. We recommend elimination of the mold and repair of all rotted wood with remedy as necessary by qualified structural contractor.

CA - Water stains were observed on numerous floor joists. Some of the areas were damp to the touch at the time of the inspection. We recommend that the source of the water be located and corrected with remedy as necessary.

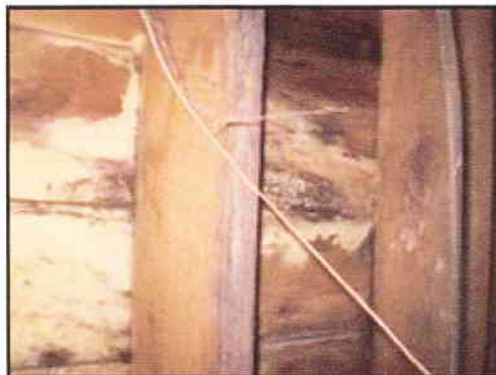
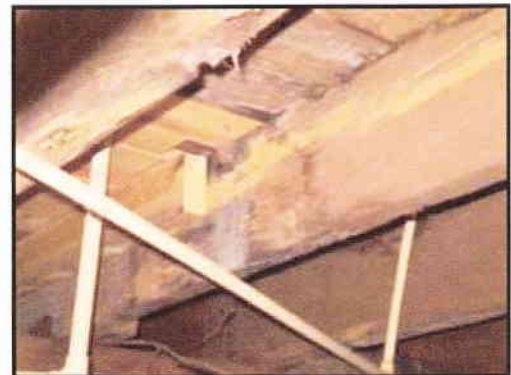
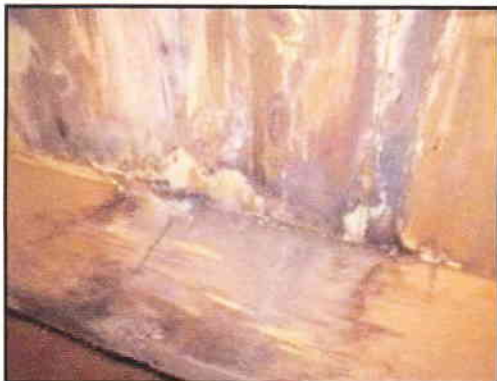
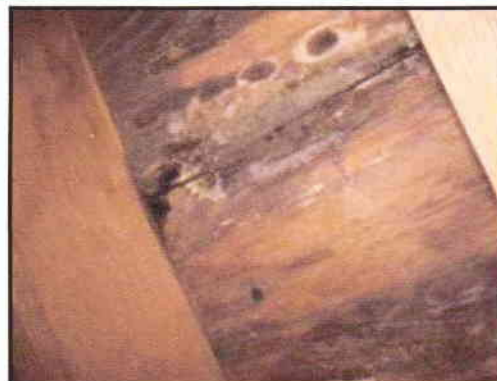
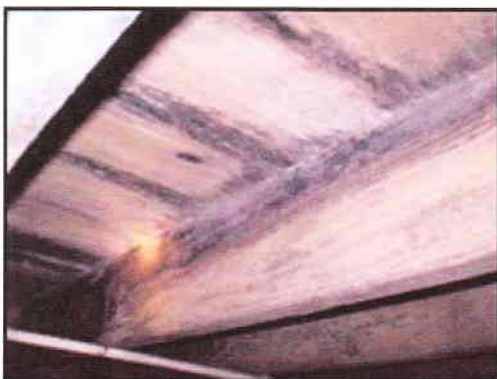
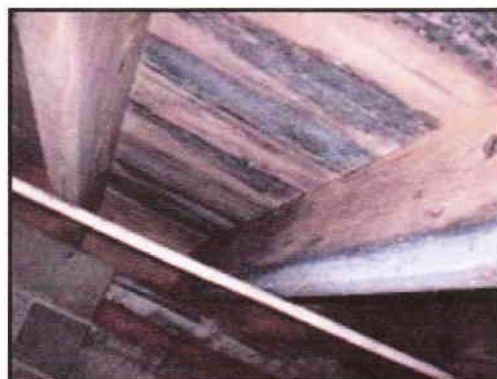
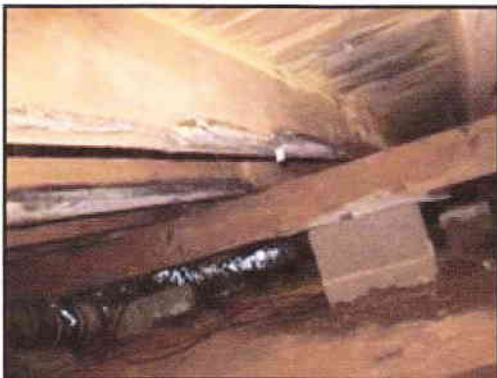
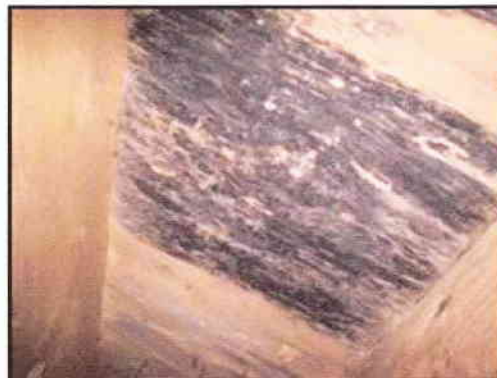
CA - Water stains were observed under some of the sections. Some of the areas were damp to the touch at the time of the inspection. We recommend that the source of the water be located and corrected with remedy as necessary.

CA - One or more areas of the sub-flooring has a condition that is consistent with and characteristic of mold and was observed throughout the flooring area within the crawlspace. Mold can break down the cell structure of the wood causing to a condition that consistent with and characteristic of dry rot. We recommend elimination of the mold and repair of all rotted wood with remedy as necessary by a qualified structural contractor.

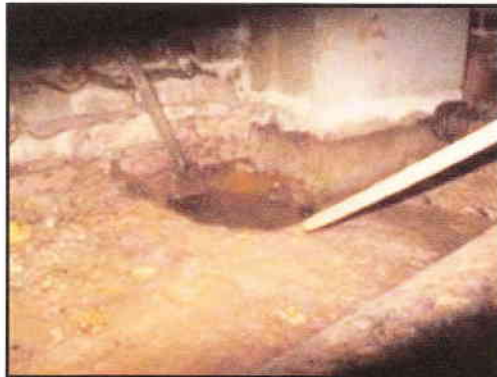
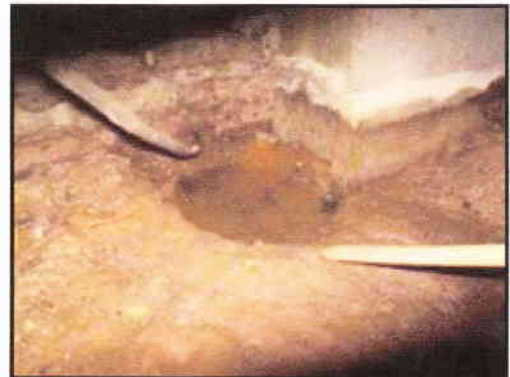
CA - The crawl space was excessively moist, with some soil extra soft or muddy. This is a condition conducive to structural settlement, wood destroying organisms and rusting of mechanical components. We recommend that the source of the moisture be determined and eliminated and that the crawl space be properly ventilated.

CA - An area at the rear/back side of the crawl space, below the bathroom area was observed to have a pool of water. This area is near the foundation wall and over time, could affect the integrity of the foundation. We recommend that the source of the moisture be determined and eliminated, the area surface be repaired and that the crawl space be properly ventilated.

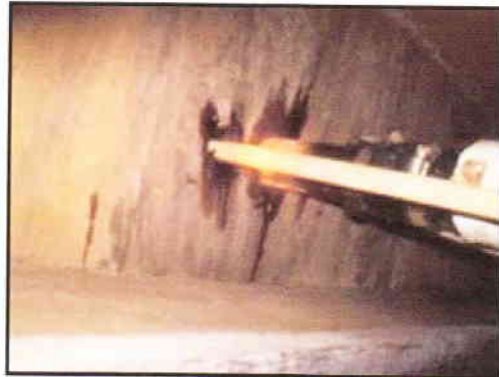
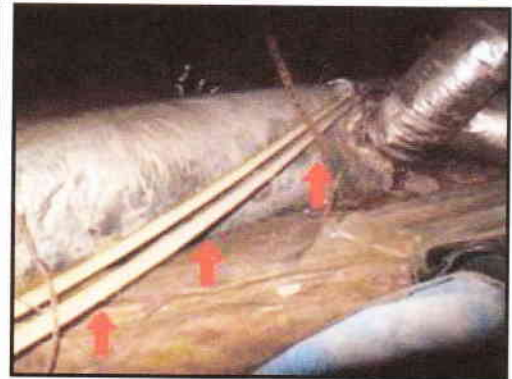
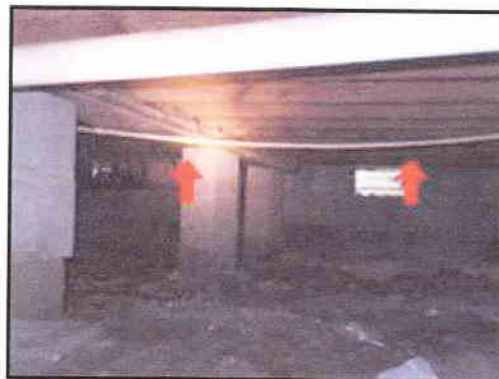
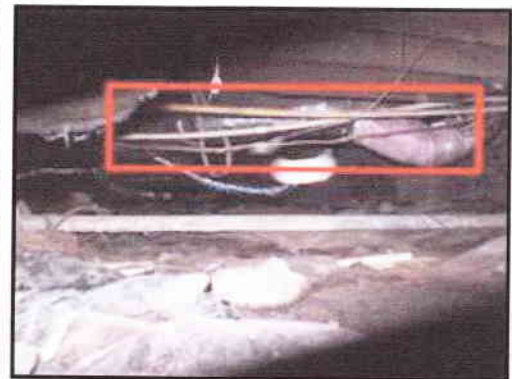
CA - There was evidence of leakage at the exposed and accessible

supply piping. We recommend repair with remedy as necessary by a qualified plumber.

CA - The water supply piping located within the crawl space lacks proper supports and hangers. We recommend that appropriate and proper supports and hangers be installed with remedy as necessary by a qualified plumber.

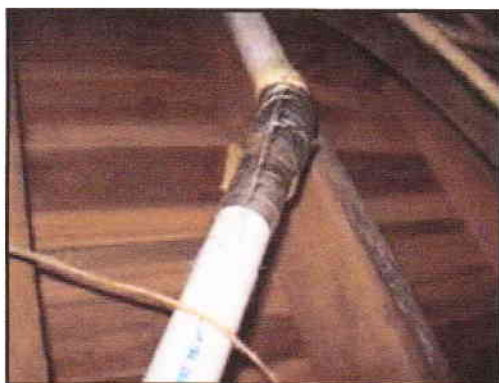
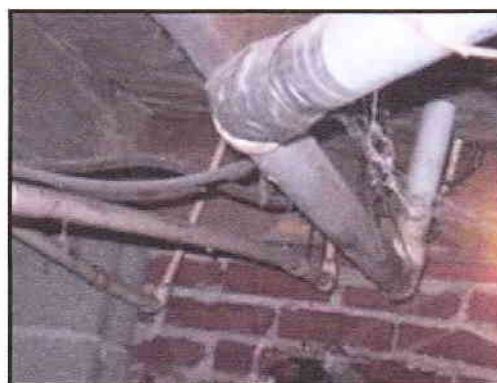
CA - One or more of the visible and readily accessible drain, waste and ventilation lines was observed to be damaged and repaired with duct tape. We recommend repair and/or replacement of the pipes by a qualified plumber with remedy as necessary.

CA - The drain, waste and ventilation lines piping located within the crawl space lacks proper supports, hangers and cross bracing in accordance with industry standards. We recommend that appropriate and proper supports, hangers and cross bracing be installed with remedy as necessary by a qualified plumber.

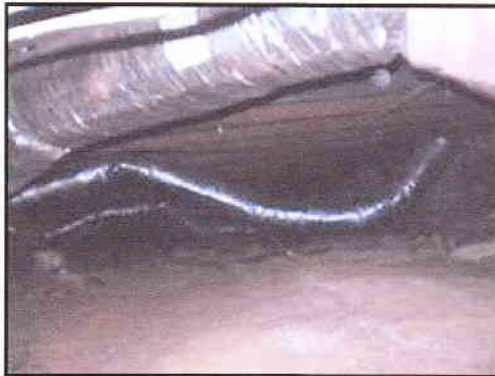
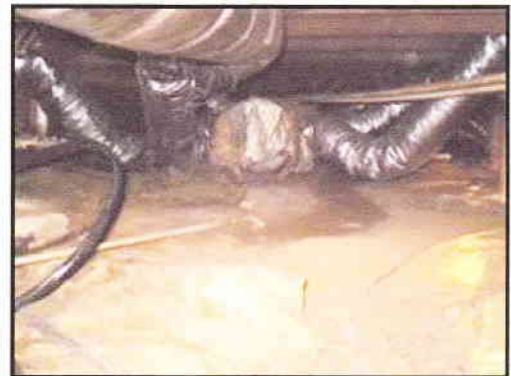
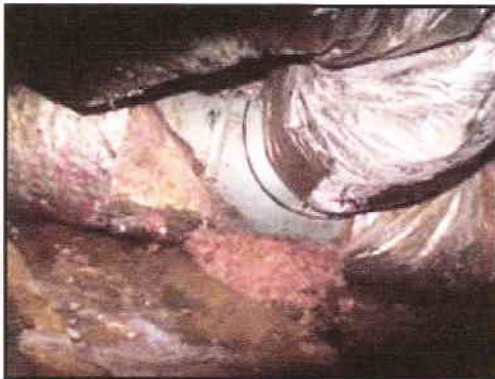
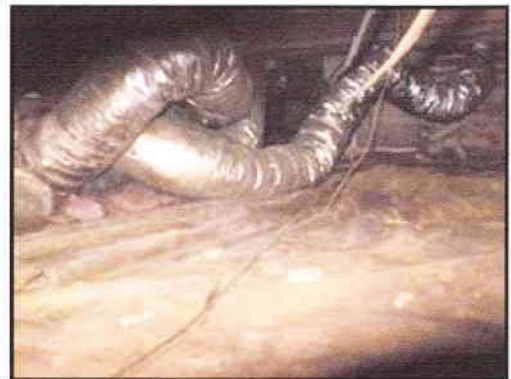
CA - One or more air ducts within the crawl space area were observed to be sagging, lack adequate strapping and/or support and are in contact with soil. These conditions may affect the HVAC system performance. We recommend that all sagging or improperly supported air ducts be re-installed in accordance with HVAC industry practices by a qualified HVAC contractor with remedy as necessary.

CA - One or more air ducts were observed to be loose, leaking,

and /or disconnected within the crawl space. This condition allows air to spill out into an unconditioned area which affects the efficiency of the HVAC system. We recommend repair and/or replacement of the air ducts with remedy as necessary by a qualified HVAC contractor.

CA - One or more of the air ducts in the crawl space were damaged. We recommend that all damaged duct work be repaired and/or replaced by a qualified HVAC contractor with remedy as necessary.

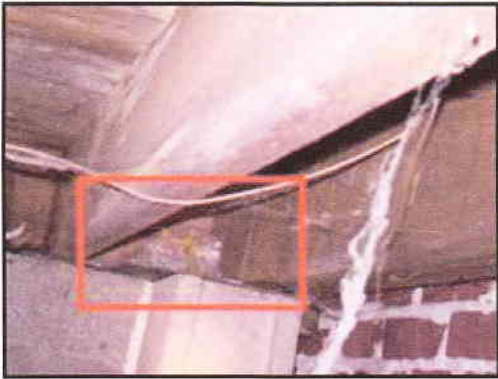
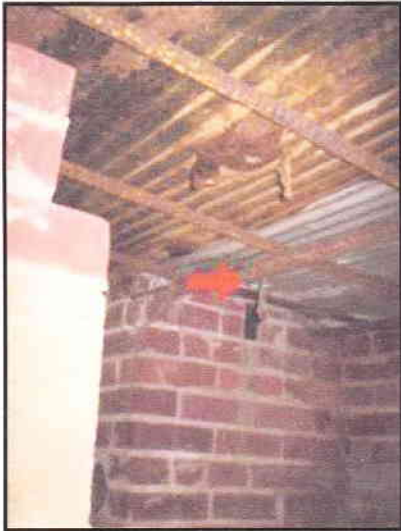
NM - A mouse nest was observed within the crawlspace, indicating past rodent activity. We recommend that the area be service by a qualified pest inspector with remedy as necessary.

NM - A shed snake skin was observed within the crawlspace, indicating past activity. We recommend that the area be service by a qualified pest inspector with remedy as necessary.
